# **INDOOR AIR QUALITY ASSESSMENT**

**Lunenburg High School  
1079 Massachusetts Avenue  
Lunenburg, Massachusetts**

Prepared by:  
Massachusetts Department of Public Health  
Bureau of Environmental Health Assessment  
November, 2001

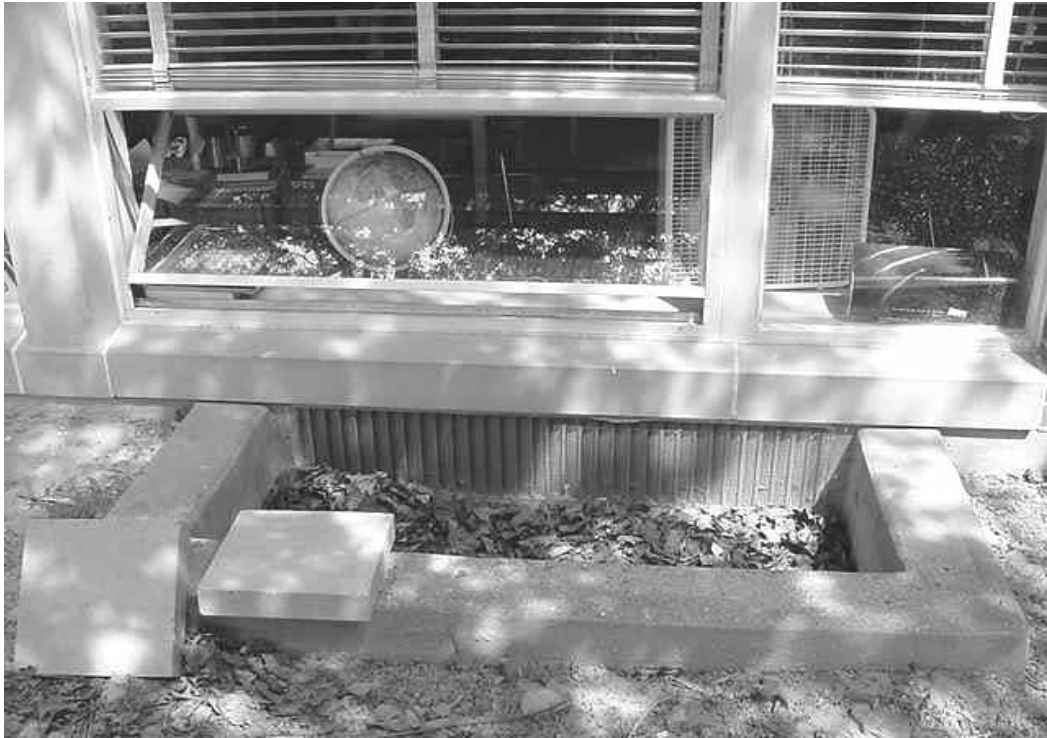
**Picture 1**

Univent fresh air intakes in the enclosed courtyard and in some areas along the outer exterior wall are located within subterranean, cement-walled pits (see Picture 1). An accumulation of leaves and debris exist below a number of these fresh air intakes. Wet leaves can provide a medium for mold growth & odors that can be entrained into the building by the air handling equipment.

**Univent Fresh Air Intake Located in Subterranean, Cement-Walled Pit**

1. Remove leaves and other debris from univent fresh air intake subterranean pits, clean & inspect periodically.
2. Disconnect the flammable storage cabinet from the PVC pipes and reseal the cabinet with its original bung hole caps.

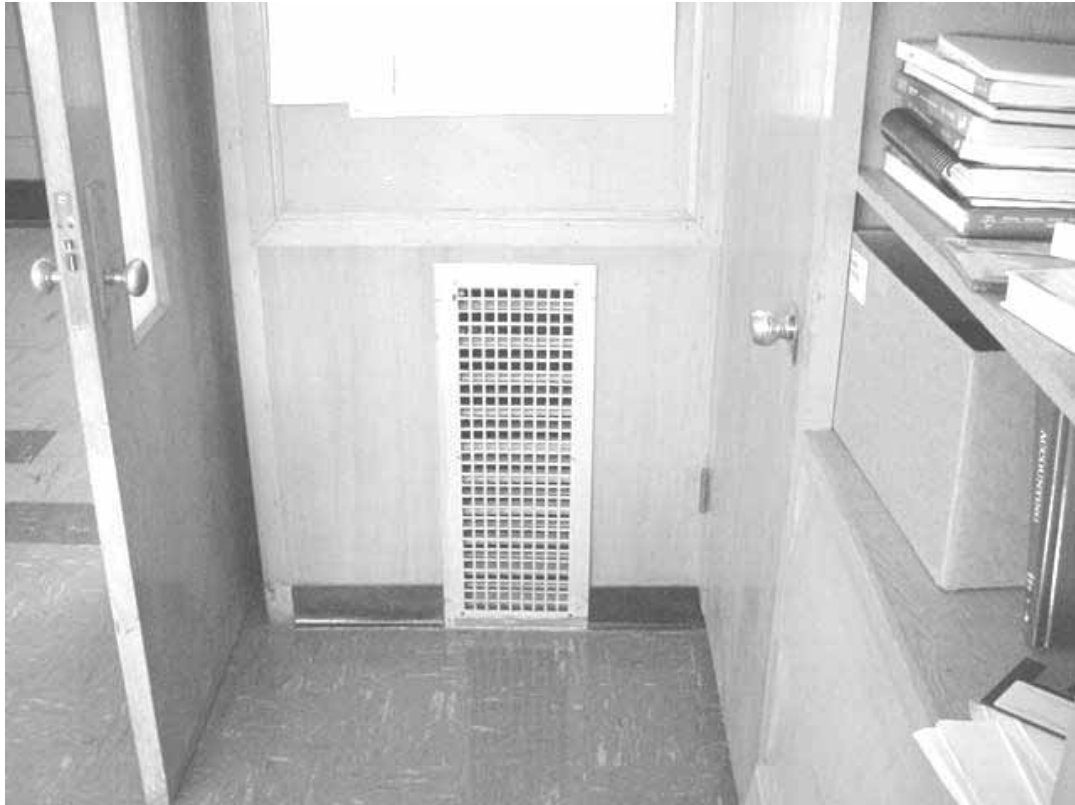
**Picture 2**

Exhaust ventilation in classrooms is provided by a mechanical system consisting of ducted, grated wall vents (see Picture 2). Exhaust ventilation was not operating in a number of areas during the assessment. Of note was room 246, which appeared to be backdrafting air into the classroom. Several exhaust vents were blocked by file cabinets or other items. In order for exhaust ventilation to function as designed, vents must be activated and remain free of obstructions.

**Exhaust Vent in Classroom**

7. Remove all blockages from univents and exhaust vents.
8. Once both the fresh air supply and exhaust ventilation are functioning, the ventilation system should be balanced by an HVAC engineering firm.

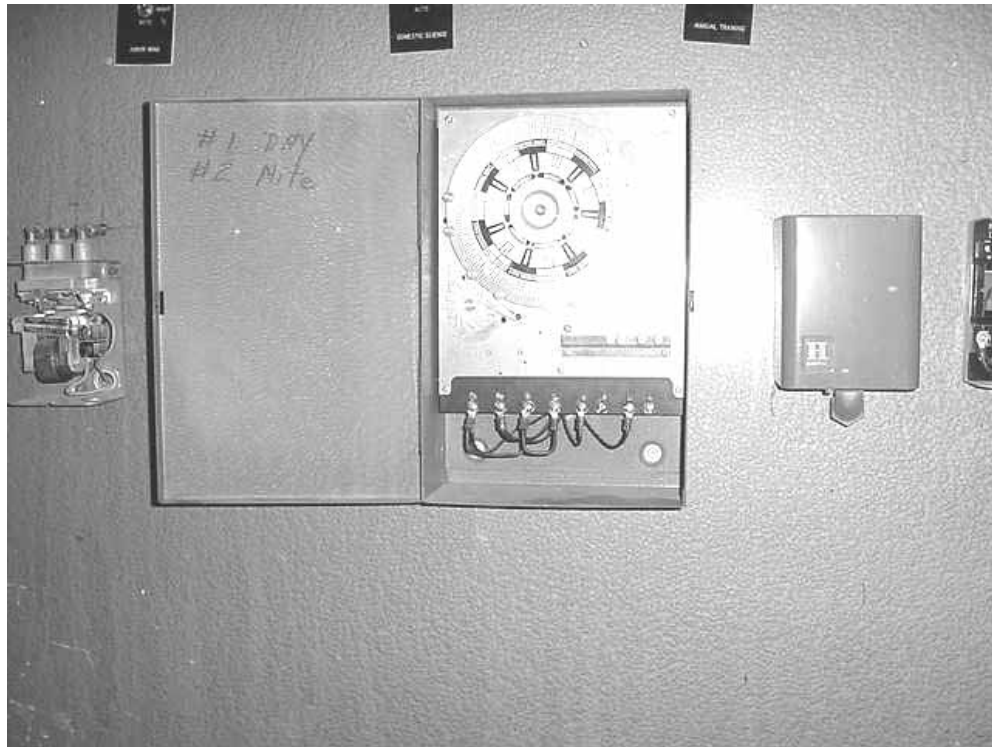
**Picture 3**

A combination of a timer system (see Picture 3) and thermostats control the ventilation system. The thermostats will deactivate univents once a predetermined temperature is achieved, called “cycling”. Ventilation is activated once room temperature drops below a set level. When the room temperature exceeds the thermostat setting, ventilation deactivates. This periodic deactivation can result in little fresh air introduction into classrooms.

**Ventilation System Timer**

3. Disconnect the vent attached to the chemical hood duct. Render the chemical hood duct airtight.
4. Repair backdrafting exhaust vents.
5. To maximize air exchange, the BEHA recommends that both supply and exhaust ventilation operate continuously during periods of school occupancy independent of classroom thermostat control.

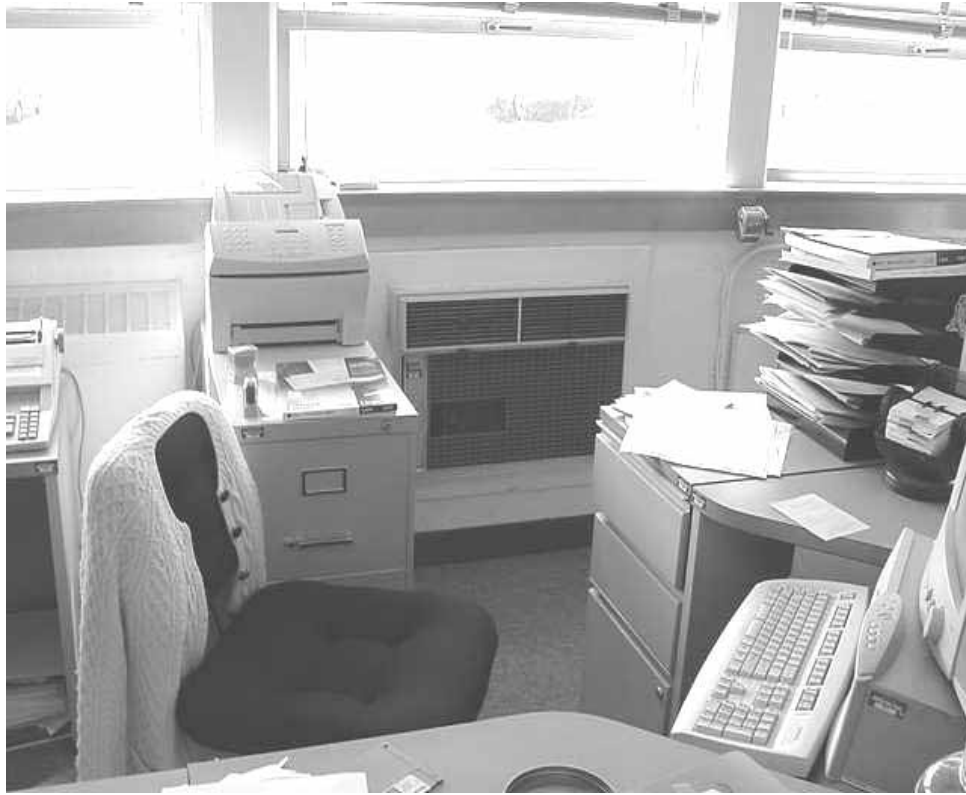
**Picture 4**

A number of areas are cooled using wall or window-mounted air conditioners (WMAC) (see Picture 4). Some air conditioners have the capacity to introduce fresh air, however the majority of installed machines recycle indoor air only.

**Wall Mounted Air Conditioner**

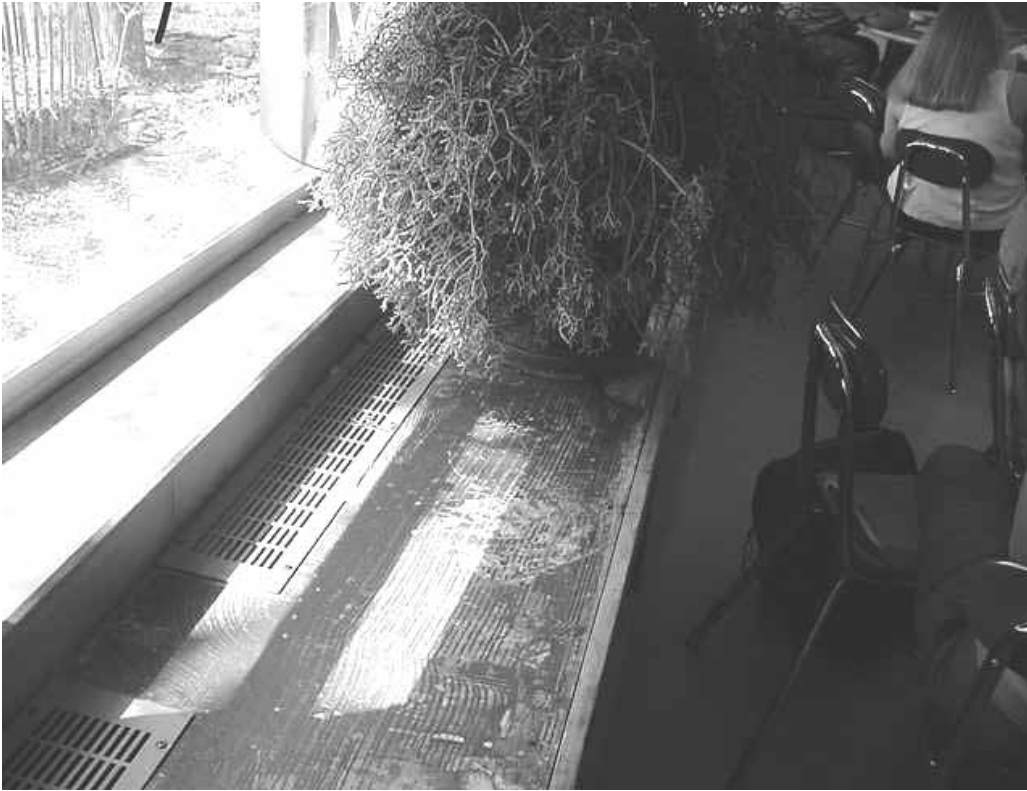
**Picture 5**

Plants were noted throughout the school. A number of classrooms have water damaged windowsills that appear to have resulted from over watering of plants (see Picture 5). In one room, large plants are located on wall-to-wall carpeting (see Picture 6). Plant soil and drip pans can serve as a source of mold growth. Plants should be located away from univents and exhaust ventilation to prevent aerosolization of dirt, pollen or mold.

**Water Damaged Window Sill That Appears To Have Resulted From Over Watering of Plants**

2. Consider replacing water damaged windowsill materials.
3. Examine the feasibility of replacing damaged gymnasium block windows.
4. Examine the feasibility of restoring exhaust ventilation for room 239.
5. Consider installing mechanical ventilation or local exhaust vent in shelter to circulate air and remove excess moisture and odors.

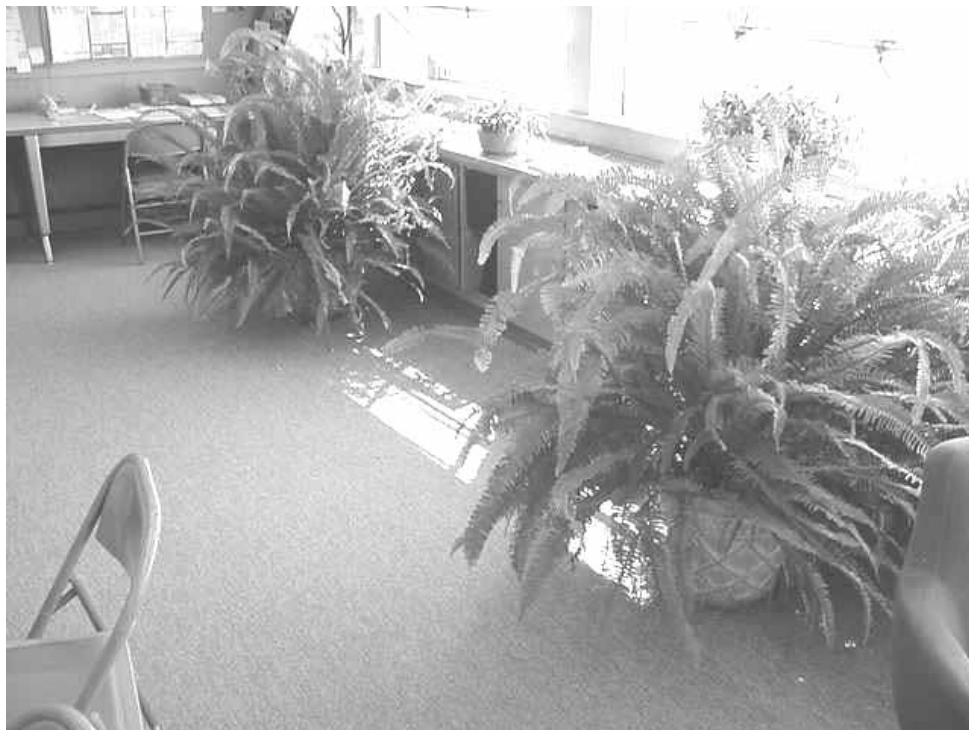
**Picture 6**

**Large Plants Located on Wall-To-Wall Carpeting**

11. Remove/relocate compost pile from inner courtyard.
12. Remove plants from floor with wall-to-wall carpeting. Move plants away from univents in classrooms. Ensure plants have drip pans. Examine drip pans periodically for mold growth and disinfect with an appropriate antimicrobial where necessary. Consider reducing the number of plants in certain areas.

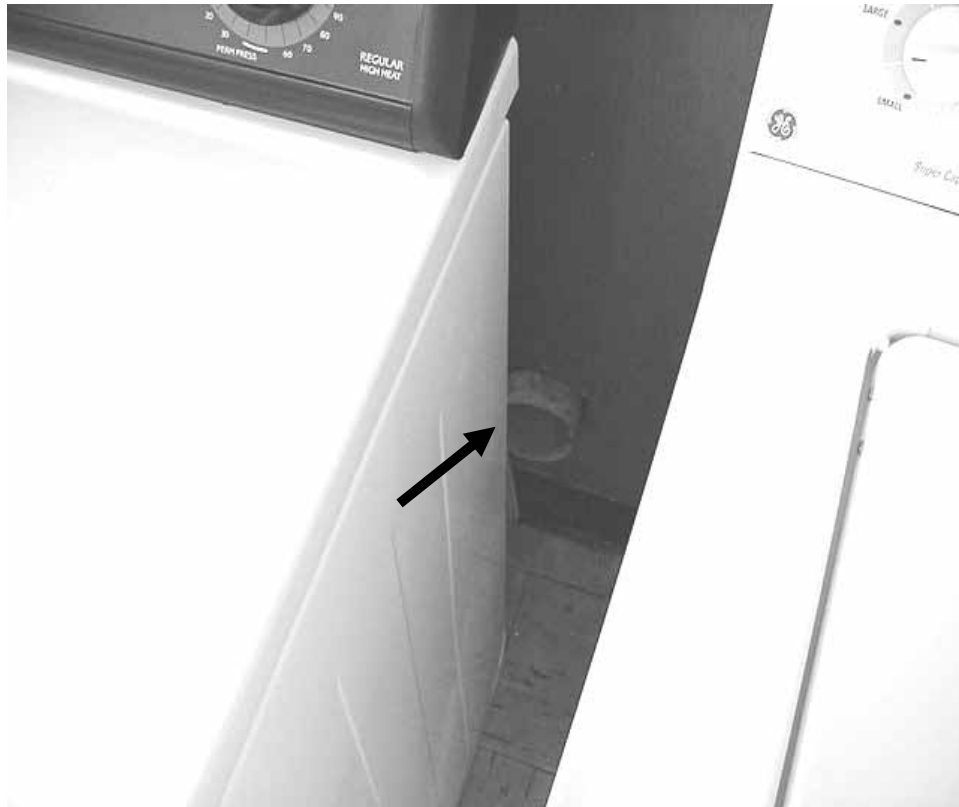
**Picture 7**

Room 234 has two clothes dryers. One dryer is disconnected from its exhaust vent (see Picture 7). The second clothes dryer terminates into a plastic appliance with open sides (see Picture 8). This configuration can add water vapor into the area when the dryers operate, increasing relative humidity. In addition, dryer lint can become aerosolized and serve as a source of eye and respiratory irritation. Uncontrolled moisture sources can also wet building materials (e.g., wallboard, carpeting), which may result in mold growth. To avoid this occurrence, clothes dryers should be vented directly outdoors.

**Dryer Disconnected From Its Exhaust Vent**

13. Obtain a flammables storage cabinet for the graphic arts program.
14. Vent clothes dryers directly outdoors.
15. Repair water damaged sink countertops.

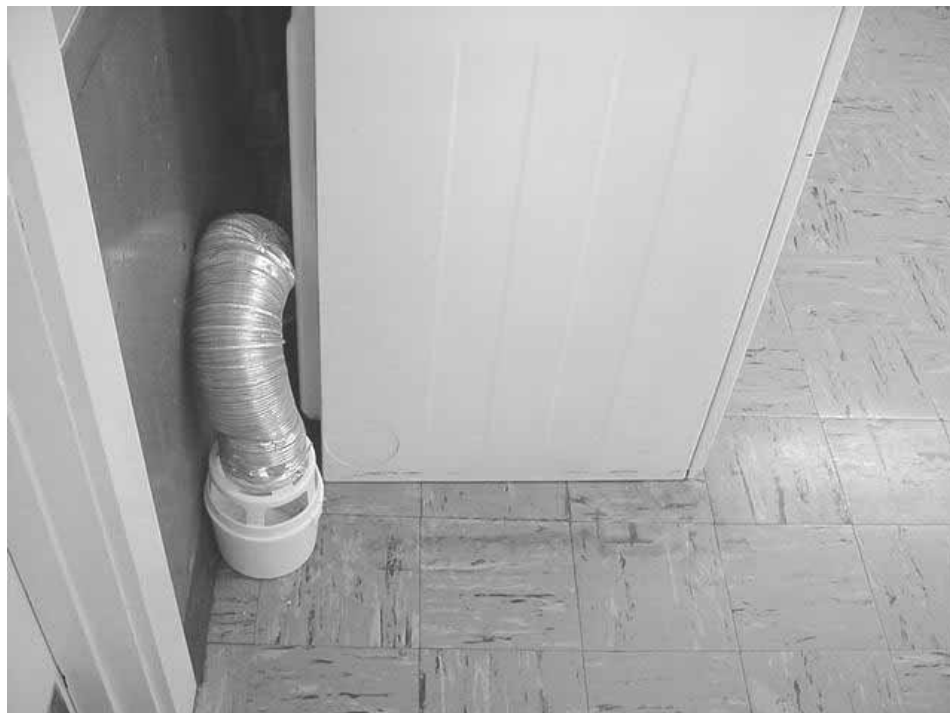
**Picture 8**

**Second Clothes Dryer Terminating into A Plastic Appliance with Open Sides**

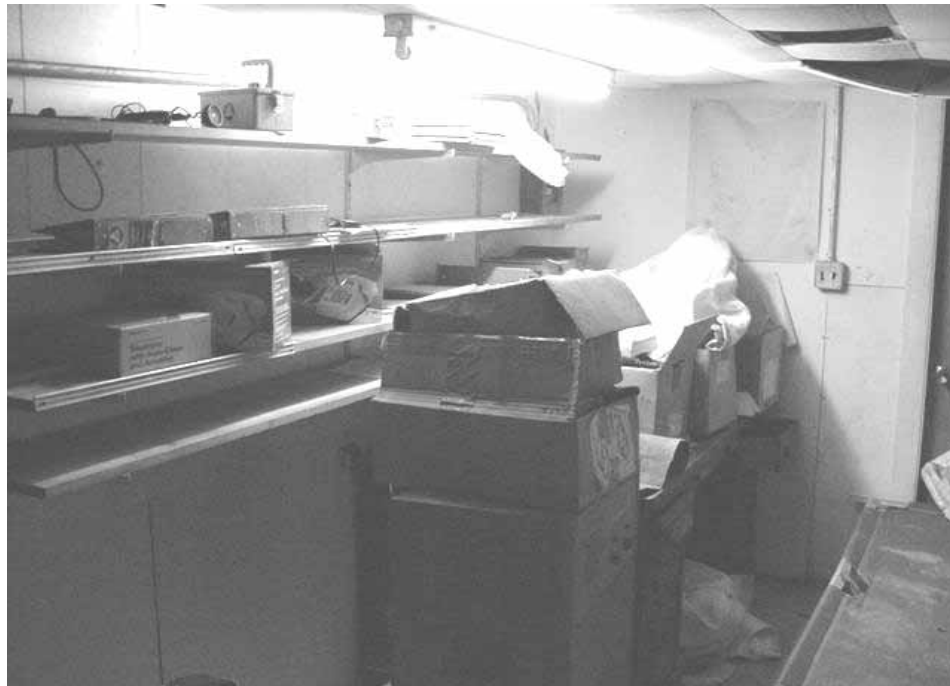
**Picture 9**

A fall out shelter exists in the ground floor near the core of the building (see Picture 9). This area does not have a ventilation system. BEHA staff detected a significant musty odor upon entering the fall out shelter. The source of the odor appears to be the numerous paper, cardboard, cloth and other porous materials that were stored in the subterranean, unventilated space. Without dilution and/or removal by mechanical ventilation odors and moisture can build up in this area.

**Fallout Shelter**

24. Remove mold colonized materials from the fall out shelter. Disinfect non-porous surfaces with an appropriate antimicrobial.
25. Examine and repair WAC installations to prevent water penetration as needed.

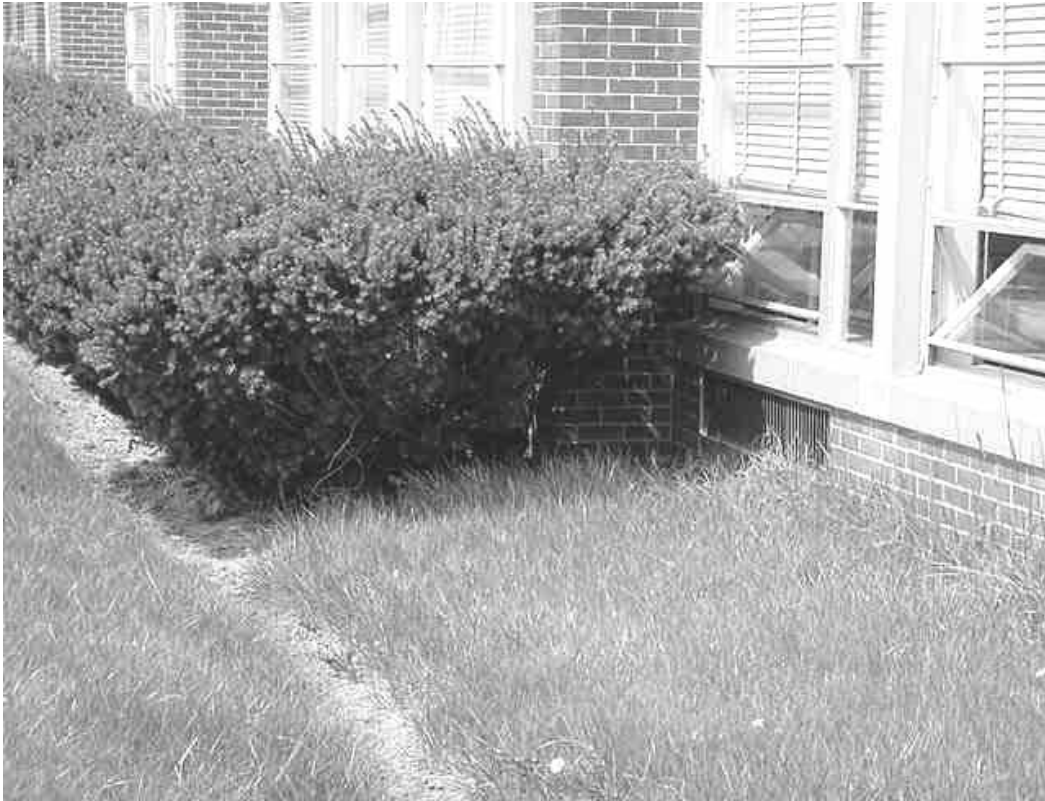
**Picture 10**

Shrubbery was noted in direct contact with the exterior wall brick or was in close proximity to univent fresh air intakes in several areas around the building (see Picture 10). Plants were growing directly against the building. Shrubbery can serve as a possible source of water impingement on the exterior curtain wall. Plants retain water and in some cases can work their way into mortar and brickwork causing cracks and fissures, which may subsequently lead to water penetration and possible mold growth.

**Shrubby in Direct Contact with the Exterior Wall Brick**

19. Cut shrubbery in a manner to maintain a space of 3 feet from univent fresh air intakes.
20. Examine the feasibility of moving buses away from the building. Instruct bus drivers to adhere to the anti-idling law.

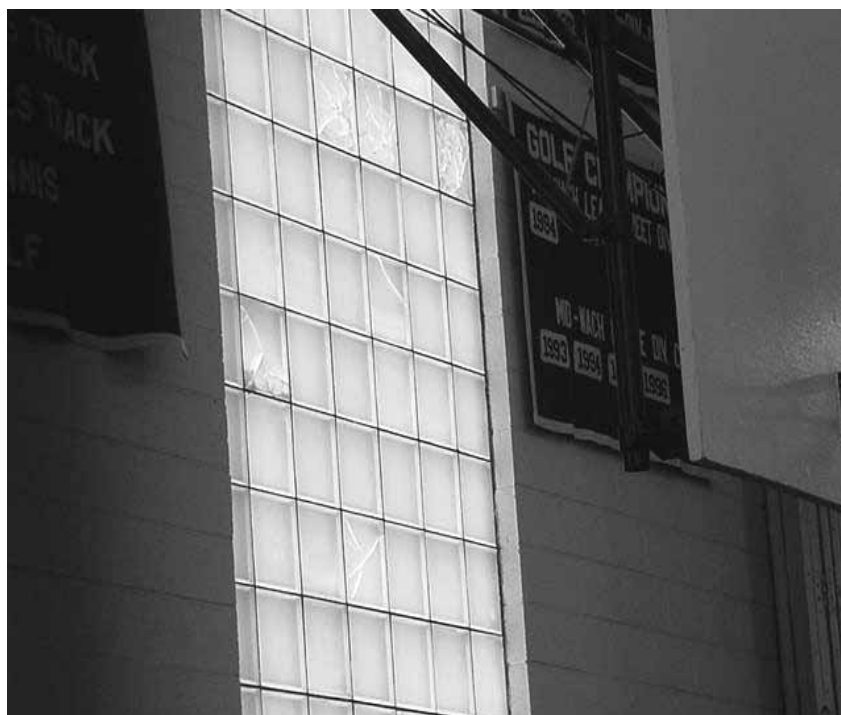
**Picture 11**

The gymnasium had cracked block windows (see Picture 11). In addition, some WAC installations for the print shop had signs of water damage along seams (see Picture 12). Cracks in windows and spaces around WMAC installations can serve as pathways for water to penetrate into the interior of a building.

**Cracked Block Windows in Gymnasium**

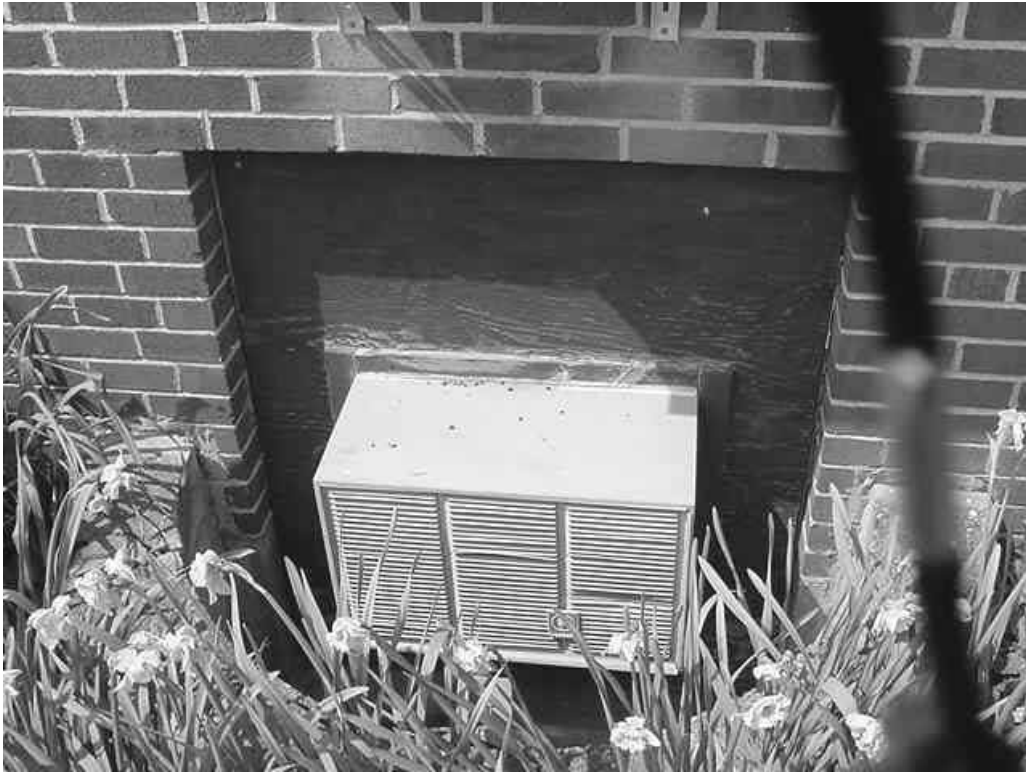
**Picture 12**

**WAC Installations for the Print Shop Show Signs of Water Damage along Seams**

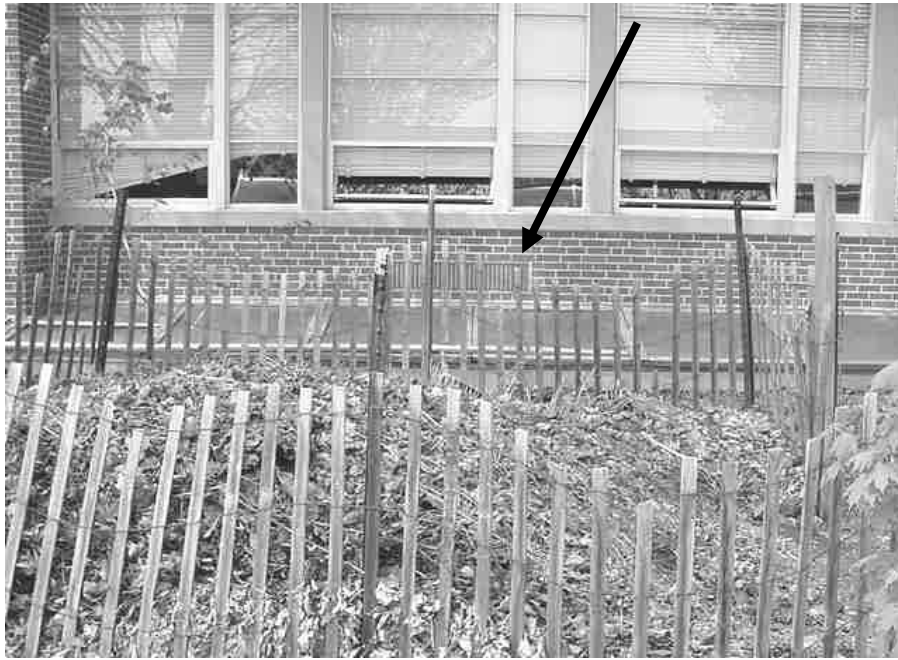
**Picture 13**

Within the central courtyard is a greenhouse. Also within this area is a compost heap (see Picture 13) in close proximity to a classroom fresh air intake. Compost heaps may be a source of odors as materials degrade, particularly if the piled materials are not turned regularly. As with shrubbery, compost heaps can be a source of odor, particulates and microbes that can be entrained by the univents in the courtyard.

**Compost Heap in Close Proximity to A Classroom Fresh Air Intake.**

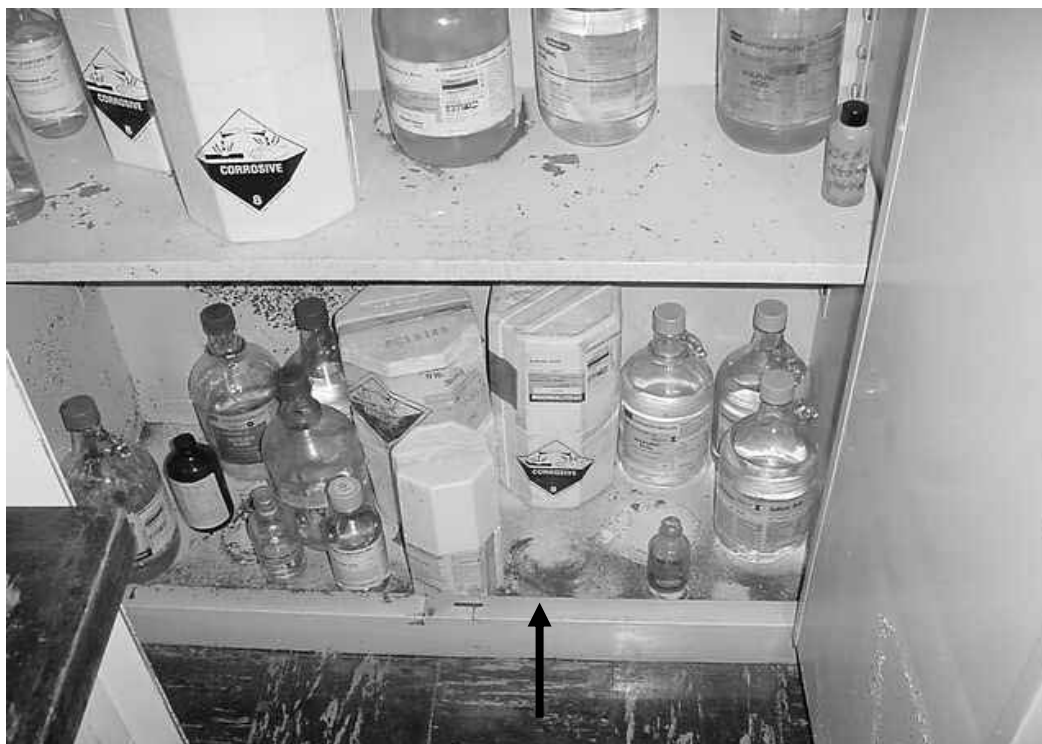
**Picture 14**

A number of other conditions were noted during the assessment, which can affect indoor air quality. The chemical storage area is contained in two rooms. The interior room contains a flammable storage cabinet that is used to store acids (see Picture 14). The interior of the cabinet is corroded from off-gassing acids. The corroding of the metal shelf supports can lead to the undermining of the structural integrity of the shelves. An accidental bump to the shelf could cause these shelves to fail, resulting in the breakage of the glass containers and subsequent opportunity for acid release into the chemical storage area. Under the observed condition of these shelves, it is highly recommended that stored containers be removed to prevent shelf failure. Acids should be stored in an acid resistant cabinet.

**Flammable Storage Cabinet Used to Store Acids, Note Corrosion**

16. Obtain an acid resistant cabinet for storage of acids.
17. Have a chemical inventory done in all storage areas and classrooms. Properly store flammable materials in a manner consistent with the local fire code. Discard hazardous materials or empty containers of hazardous materials in a manner consistent with environmental statutes and regulations. Label chemical containers with the chemical name of its contents. Follow proper procedures for storing and securing hazardous materials.

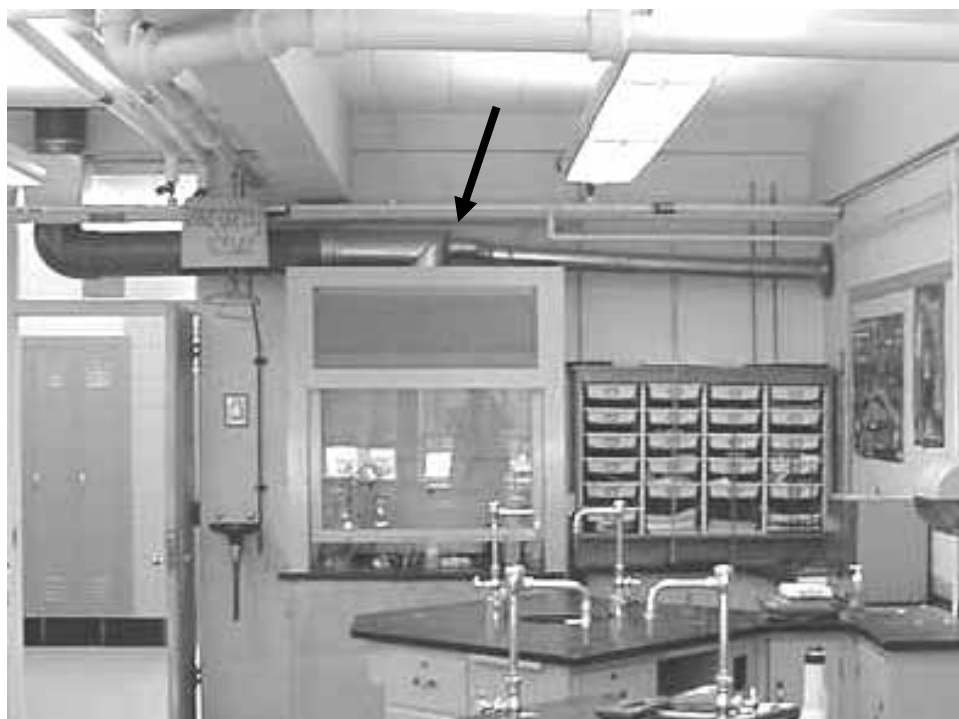
**Picture 15**

The chemistry classroom contains a chemical hood (see Picture 15). The exhaust duct above the chemical hood is connected to a duct that serves as the exhaust vent for

**Chemical Hood in the Chemistry Classroom, Note Duct Connection**

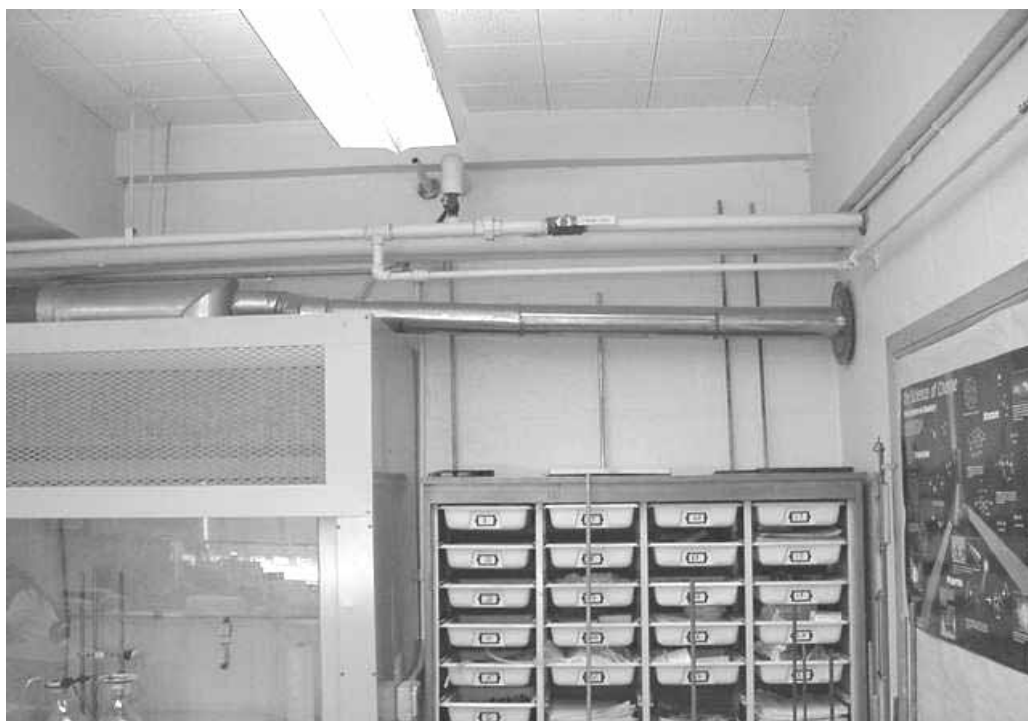
**Picture 16**

the interior chemical store room (see Pictures 16 and 17). This configuration can allow chemical vapors and fumes to enter the chemical storeroom via this ductwork when the chemical hood is deactivated. In addition, this configuration compromises the fire integrity of the chemical hood duct. The chemical hood duct should exit the building directly without breaches to prevent both fire and chemical backdraft.

**Exhaust Duct for Chemical Hood Connected To Duct That Serves As the Exhaust Vent  
For The Interior Chemical Store Room**

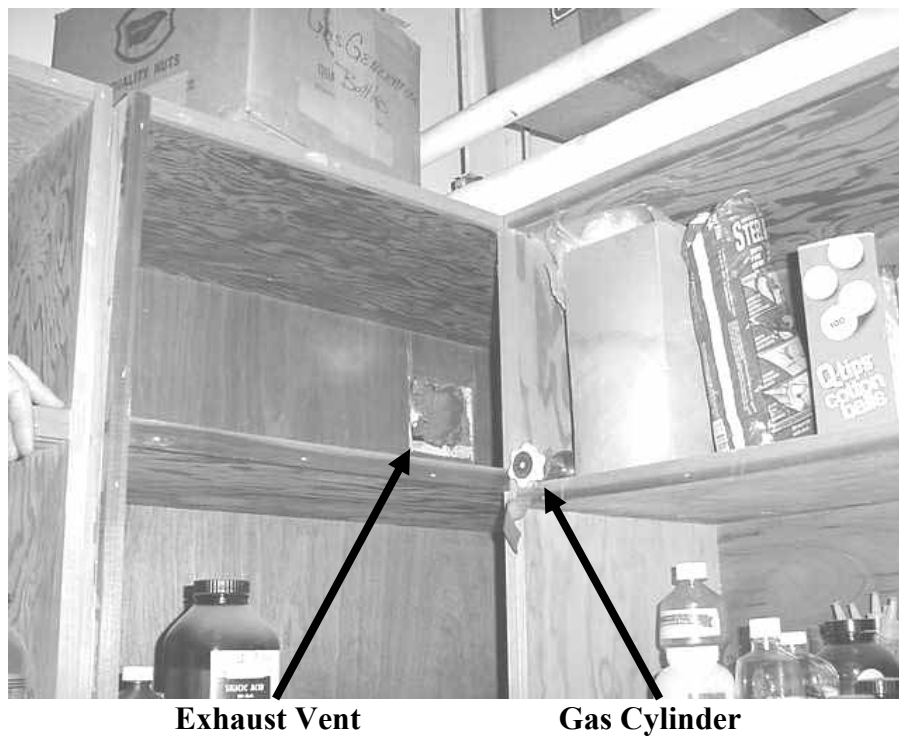
**Picture 17**

storage practice standards, cylinders of compressed gas must be fixed to a wall or stand to prevent damage to cylinder valves by tipping (Rose, S. L., 1984). A damaged cylinder valve can cause an immediate and uncontrolled release of the cylinder contents and result in the cylinder becoming a projectile. These cylinders must be secured as soon as possible to prevent accidental release and injury.

**Open Exhaust Vent for the Interior Chemical Storeroom, Note Gas Cylinder**

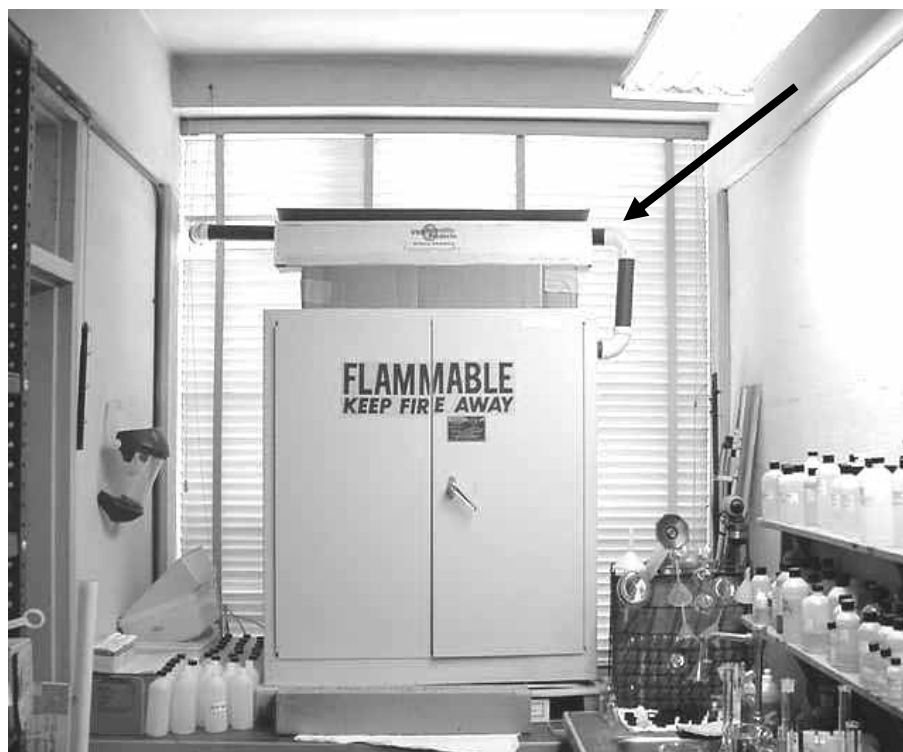
**Picture 18**

The outer room of the chemical storage area contains a flammable storage cabinet vented to the outdoors through the window system using PVC pipe (see Picture 18). The National Fire Prevention Association (NFPA) does not require venting in flammable storage cabinets. However, if venting is done, it must be vented directly outdoors and in a manner not to compromise the specific performance of the cabinet (NFPA, 1996). If air backflow from outdoors into the cabinet through the venting occurs, off-gassing chemicals can be forced from the flammable storage cabinet into the storeroom. Proper design of exhaust vents should prevent air backflow into the cabinet. The flammable storage cabinet also contained a metal turpentine container that was corroded, which can destroy the integrity of the container (see Picture 19). Several other conditions of improperly stored materials were also found in the science wing:

**Flammable Storage Cabinet Vented To the Outdoors Through the Window System Using PVC Pipe**

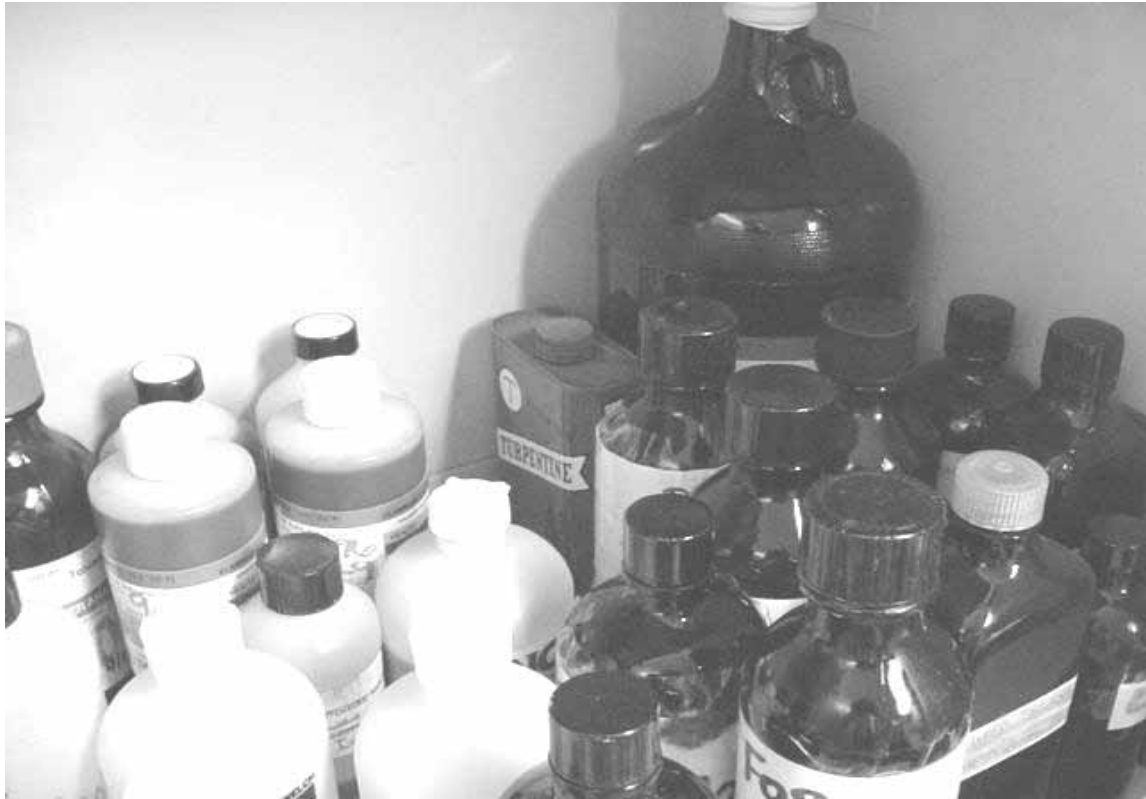
**Picture 19**

**Corroded Metal Turpentine Container**

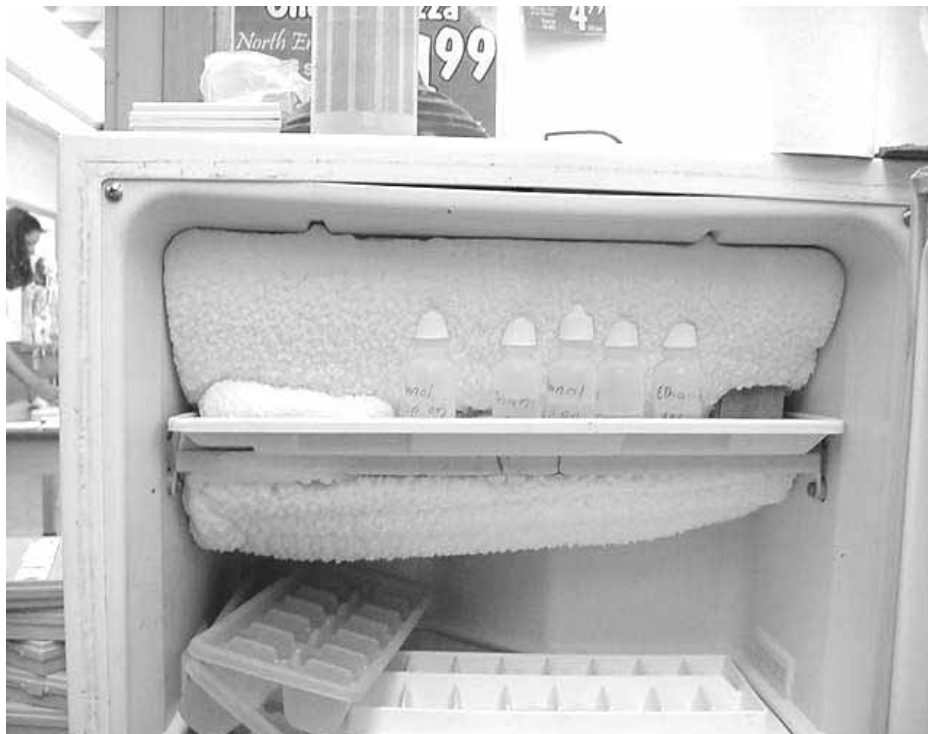
**Picture 20**

6. A refrigerator used for storage of chemicals had storage containers imbedded in accumulated freezer frost (see Picture 20). Freezing of containers can result in cracking of plastic and release of stored chemicals into the refrigerator interior.

**Storage Containers Imbedded In Accumulated Freezer Frost**

22. Install guard along edge of chemical storage area shelves.
23. Defrost refrigerator and remove chemical. If containers are damaged, dispose of chemicals in a manner consistent with Massachusetts hazardous waste laws and regulations.

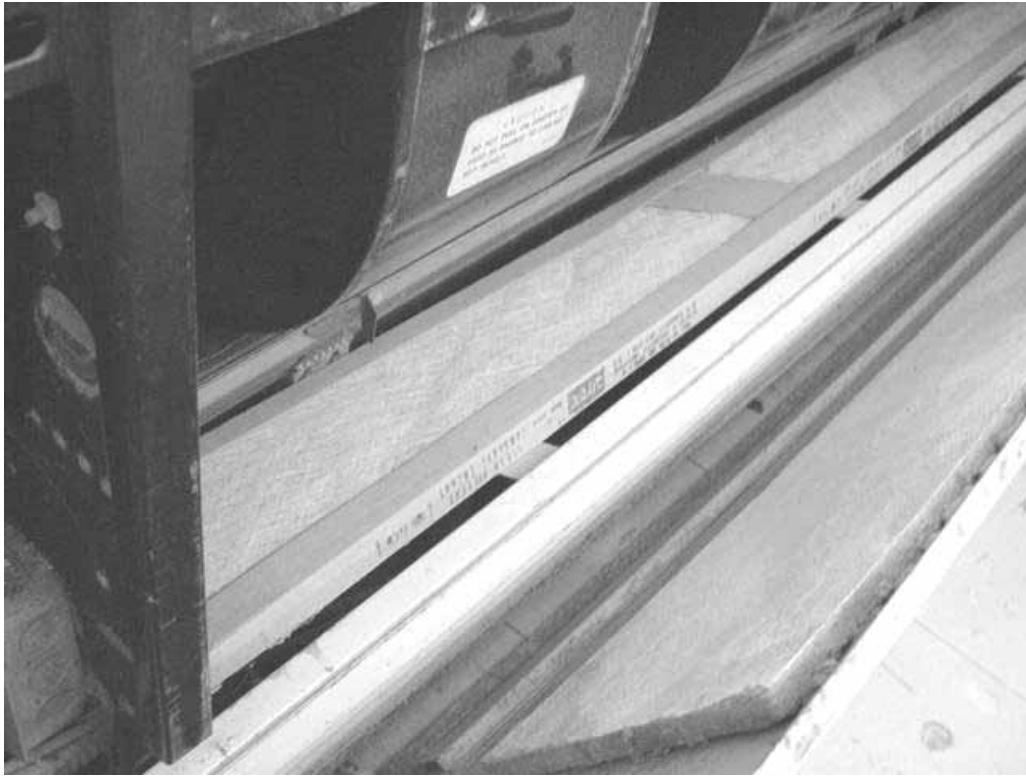
**Picture 21**

Each univent is outfitted with a filter that strains particulates from airflow. Filters were either undersized (see Picture 21) or were of a type that provide minimal filtration of airborne respirable dust. In this condition dust, dirt and other debris can then be re-aerosolized by the ventilation system. In order to decrease aerosolized particulates, disposable filters with an increased dust spot efficiency can be installed. The dust spot efficiency is the ability of a filter to remove particulates of a certain diameter from air passing through the filter. Filters that have been determined by ASHRAE to meet its

**Undersized Univalent Filter, Note Space around Edge**

18. Examine the feasibility of installing disposable filters with an increased dust spot efficiency in univents. Prior to any increase of filtration, each univent should be

evaluated by a ventilation engineer as to whether it can maintain function with more efficient filters.

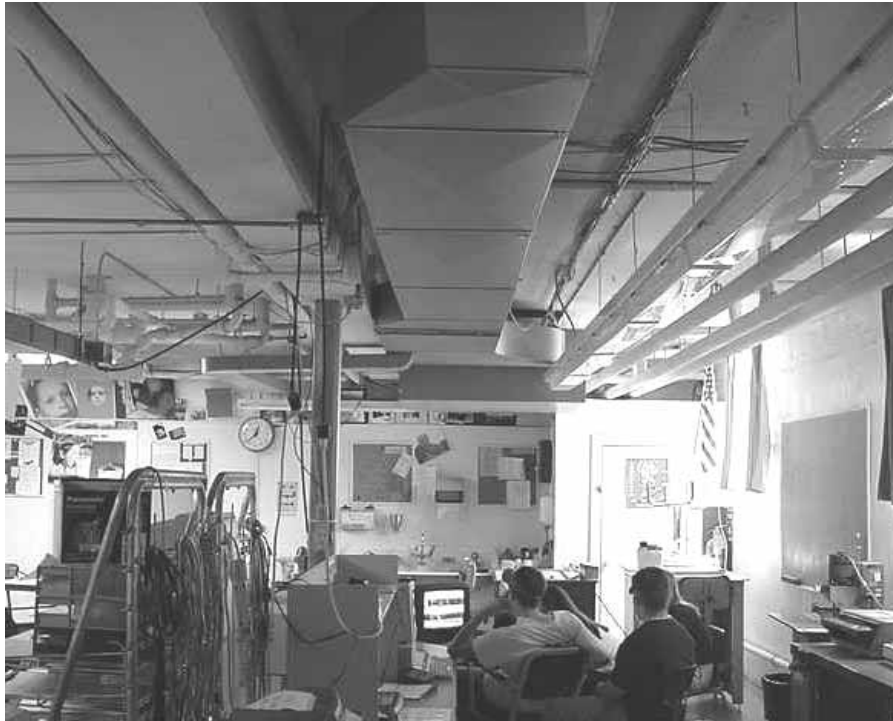
**Picture 22**

The print shop (graphics) has no local exhaust ventilation for printing presses (see Picture 22). Inks containing volatile organic compounds (VOCs) are used in this classroom without any local exhaust ventilation. VOCs can be irritating to the eyes, nose, throat, and respiratory systems. Products containing VOCs must be used with adequate exhaust ventilation to prevent exposure. A large number of containers of printing chemicals were found on tables. Flammable materials in schools should be stored in a flammables storage cabinet that meets design criteria set forth by the National Fire Prevention Association (NFPA, 1996).

**General Ventilation Ductwork in Graphics Area,  
No Local Exhaust Ventilation for Printing Presses**

1. Examine the feasibility of providing local exhaust ventilation for printing press machines and photocopying equipment in graphics classroom. If not feasible,

consider moving graphic arts to another room where local exhaust ventilation can be provided.

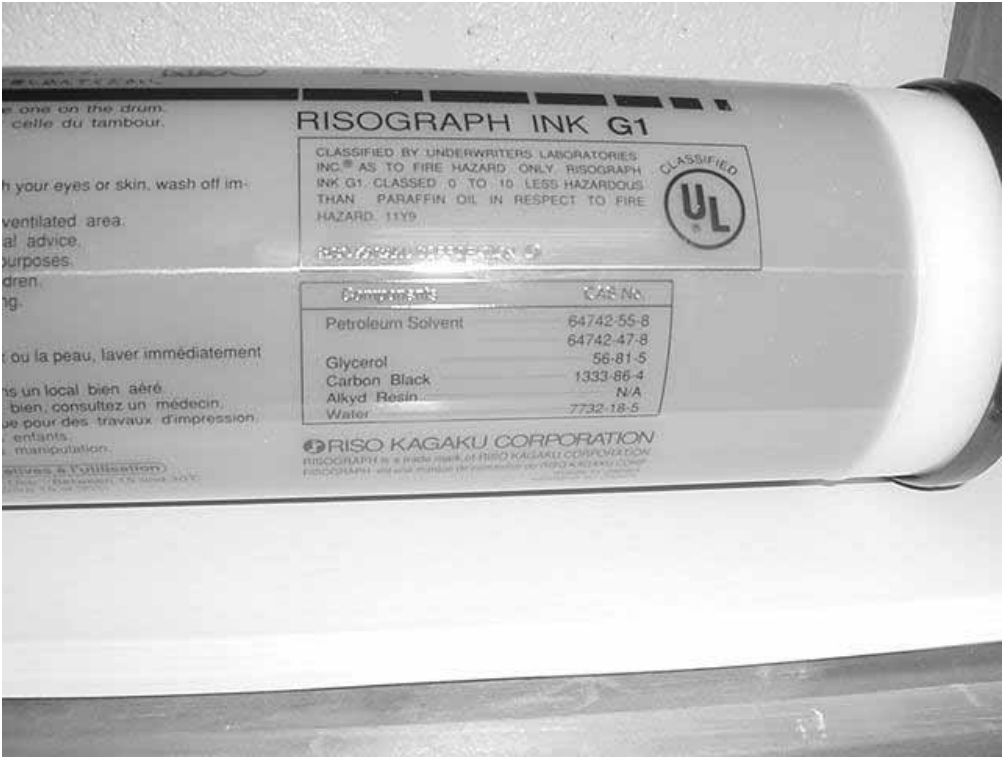
Picture 23

Three photocopiers are located in a room near the graphics classroom, in an area without local exhaust ventilation. Of note is that at least one photocopier uses a liquid toner (see Picture 23). This product contains petroleum solvent, which is a VOC. VOCs and ozone can be produced by photocopiers, particularly if the equipment is older and in frequent use. VOCs and ozone are respiratory irritants (Schmidt Etkin, D., 1992). It is recommended that local separate exhaust systems that do not recirculate into the general ventilation system be used (US DOE, unknown).

A Liquid Toner Photocopier
